Manhole Inspection Summary

Manhole # S47C__017MH

Insp Date: **7/14/08 11:58 AM**

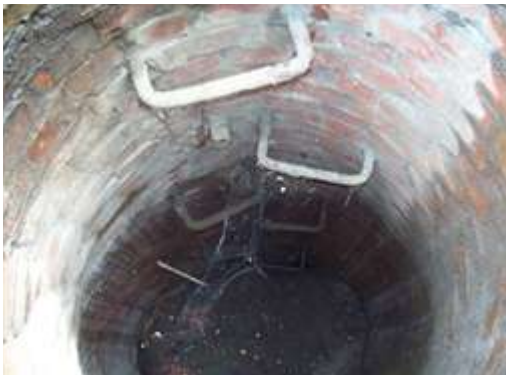
Defect 1

Infiltration: ☐ None ☐ Joint ☐ Cracks ☐ Mortar ☐ Roots ☒ **Wall**

infiltration

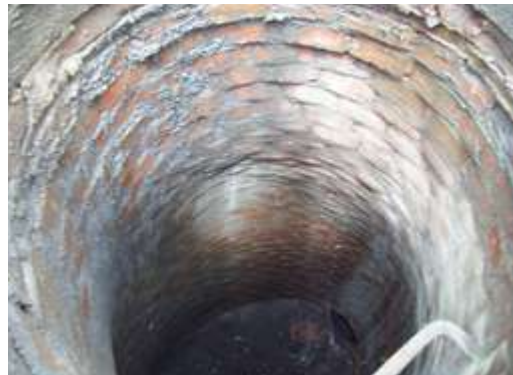
Defect 2

deterioration

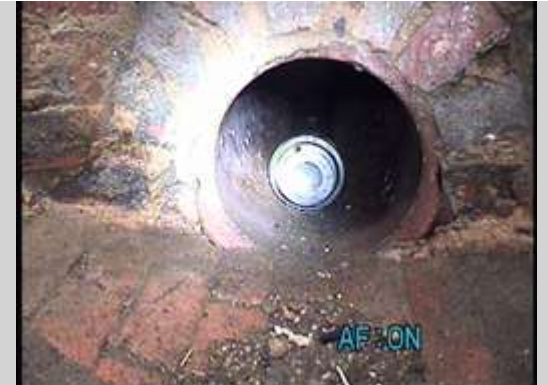
12 O'Clock Outflow

8 in. Circular Gravity Sewer
Pipe Out @ 12 O'Clock

Infiltration: **None** Pipe Seal Cond: **Sound**
